Real-time Bacterial Fluorescence Imaging Guides Antimicrobial Stewardship in Patients with Diverse Wounds

Rosemary Hill, BSN CWOCN CETN(C)¹ and Joshua Douglas, MD, FRCPC, ABIM^{1,2}

¹Infectious Disease and Critical Care Internal Medicine, ²Lions Gate Hospital, Vancouver Coastal Health, North Vancouver, BC, Canada

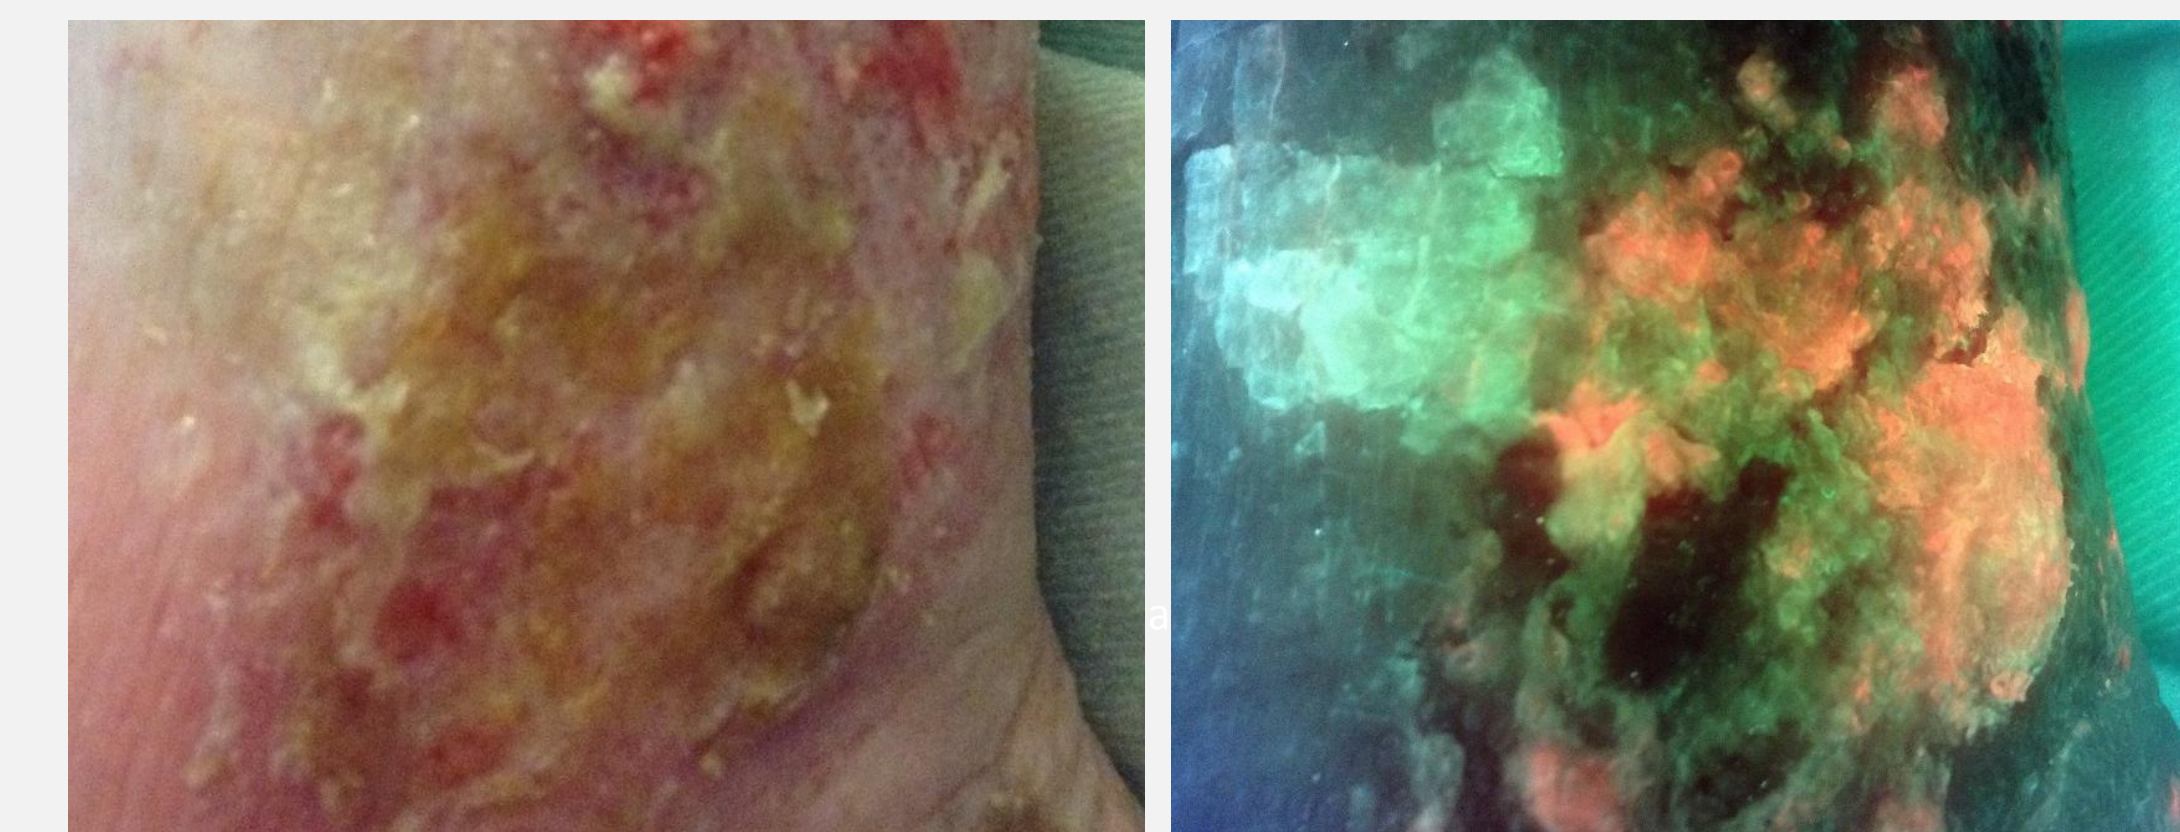
Case 3: Venous Leg Ulcer

Standard Image Bacterial Fluorescence Image (Red/pink indicates bacteria)

82-year-old female admitted for painful venous leg ulcer several days prior received wound clinician referral as team was requesting discharge with community followup. Traditional signs and symptoms of extensive erythema were not present. Yet, bacterial fluorescence images revealed extensive bacterial burden, leading to systemic antibiotic and suspension of discharge. Swabs of red/pink region confirmed heavy growth of *Acinetobacter baumannii*.

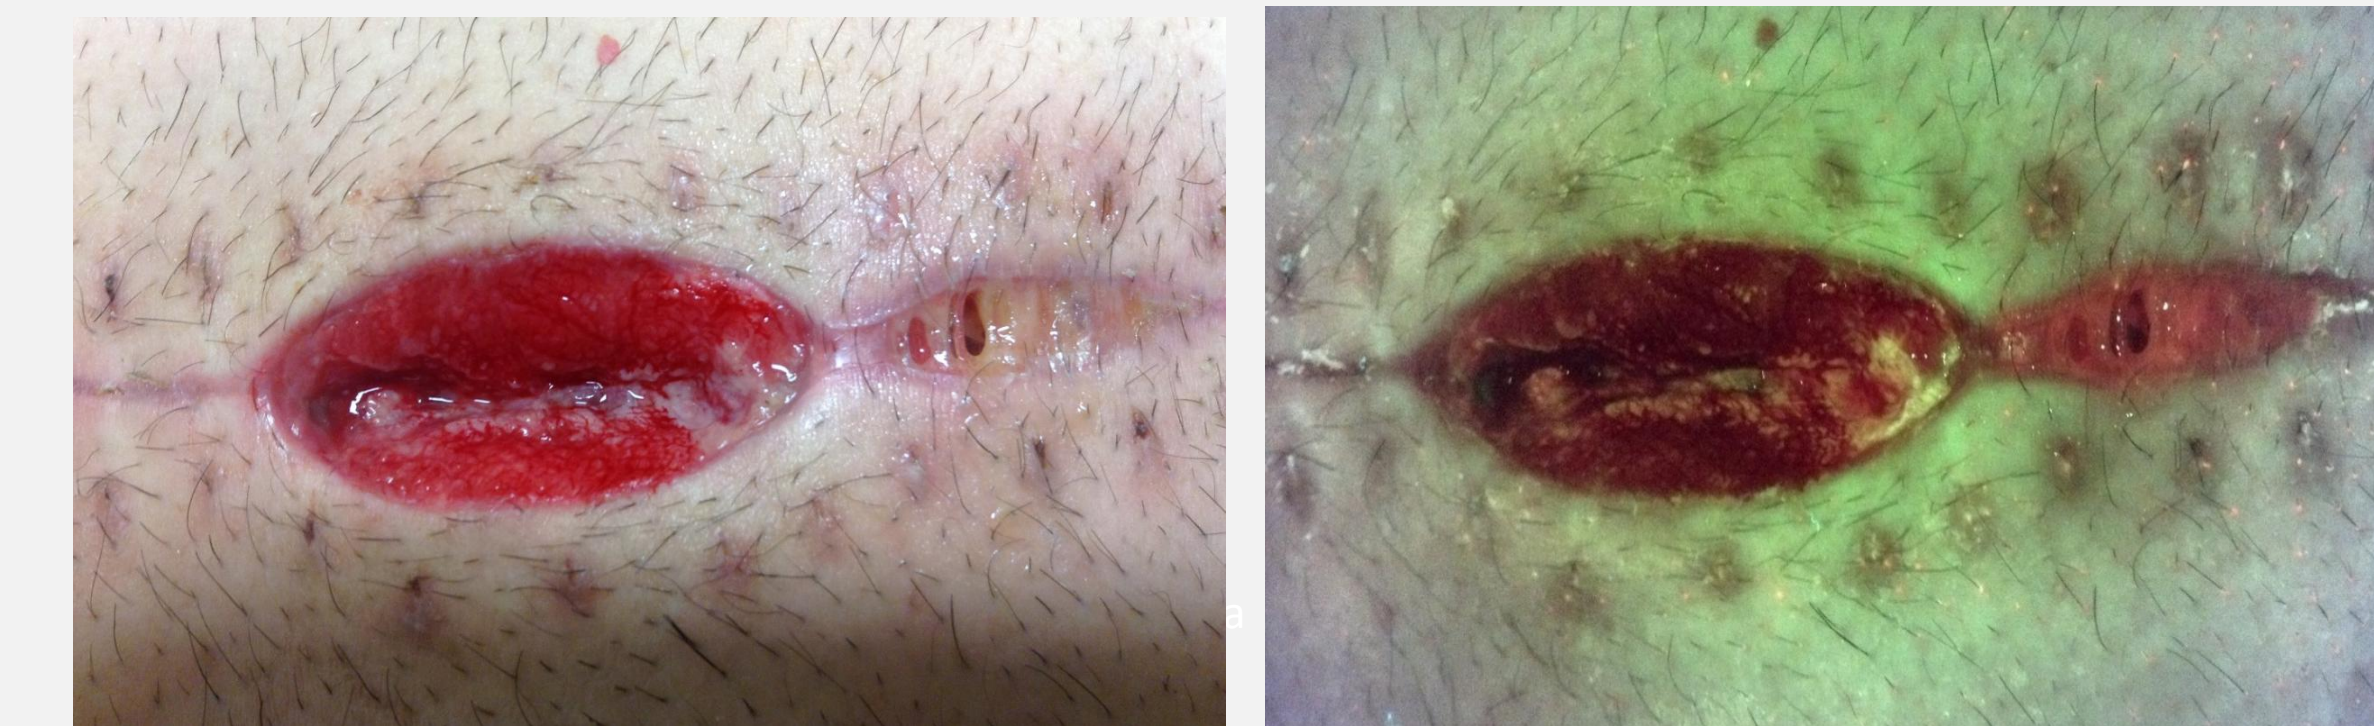
Case 6: Abdominal Wound

Standard Image Fluorescence Image (No bacterial fluorescence)

57-year-old male with gastric cancer, prescribed systemic antibiotic after partial gastrectomy. Presented with midline dehiscence, antibiotics maintained. Returned when antibiotics were to conclude concerned that midline was opening. Fluorescence images showed no evidence of contamination. These images prevented prescription of further antibiotics.

At two week follow up patient's wound was almost closed.
